SEISMIC RESISTANT RETROFITTING FOR BUILDINGS

This document was written by Aimi Elias for Practical Action in February 2011.

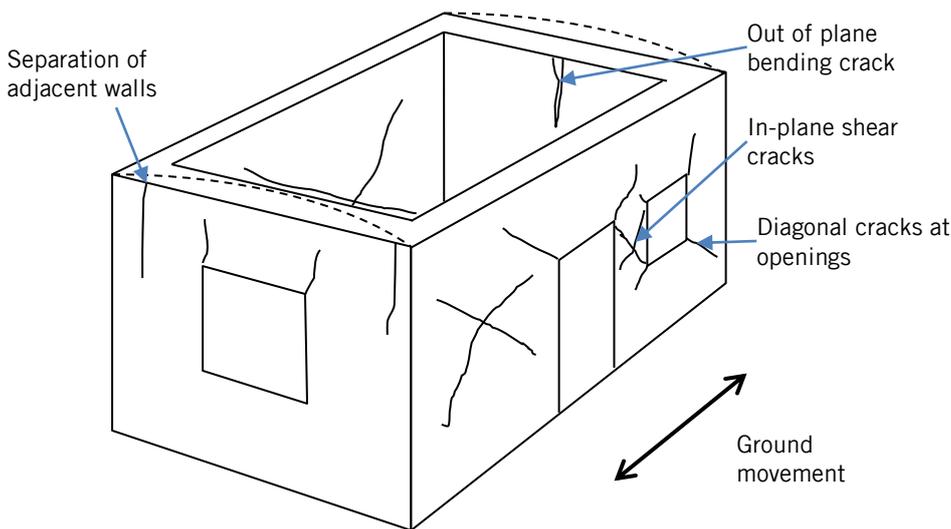
Figure 2: Damage typologies in unreinforced masonry.

The diagram above describes where cracks may first appear. Walls will experience different modes of failure depending on their orientation to the earthquake movement. Parallel to the ground movement, walls will experience shear and cracks will form in a diagonal fashion. The cracks form an X-shape because shear will be experienced in both directions to follow the ground movement. Diagonal cracks also form from the corners of openings since there stresses are highly concentrated here. Vertical cracks are formed at the middle of walls perpendicular to the ground movement, as this is the location of high bending stresses, as are ends where adjacent walls are attached. Cracking here can lead to separation of the walls at corners. Cracks can propagate and result in sections of the wall falling away and partially collapsing. In some instances, corners, sections of wall or entire walls can fall out of plumb. Prolonged shaking can also lead to delamination, in which a layer of masonry may fall away from the wall, or bulging, where the wall face separates and creates an area of thick wall. Depending on the earthquake intensity and duration, extensive damage can lead to total collapse. It is imperative that inhabitants are able to escape before collapse happens.

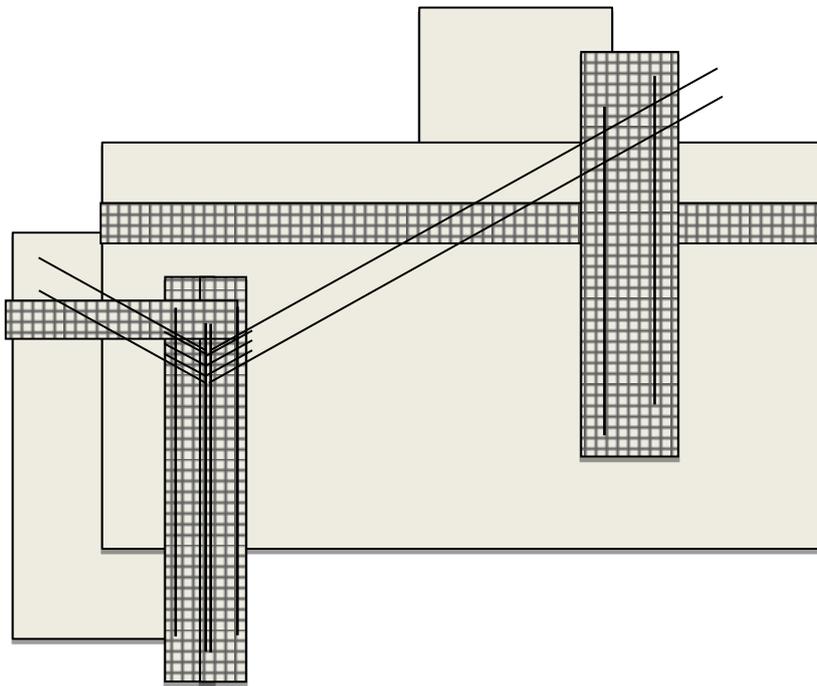
Figure 4: Illustration sketch of welded mesh configuration based on Arya (2005).

The surface should be prepared so that the mesh has good connection with the wall; this involves removing any plaster layers and cleaning to expose the masonry underneath. The mesh should be continuous and any splices should have at least a 300mm overlap.

The welded mesh should be attached to the longitudinal bars with binding wire. The strip should then be attached with 100-150mm (4-6”) nails with the nails driven into the mortar joints. Spacers should be provided to allow at least 15mm (1/2”) thickness between the wall and the mesh, to ensure the mesh is completely covered by the cement plaster. The ratio of cement: sand should be 1:3.

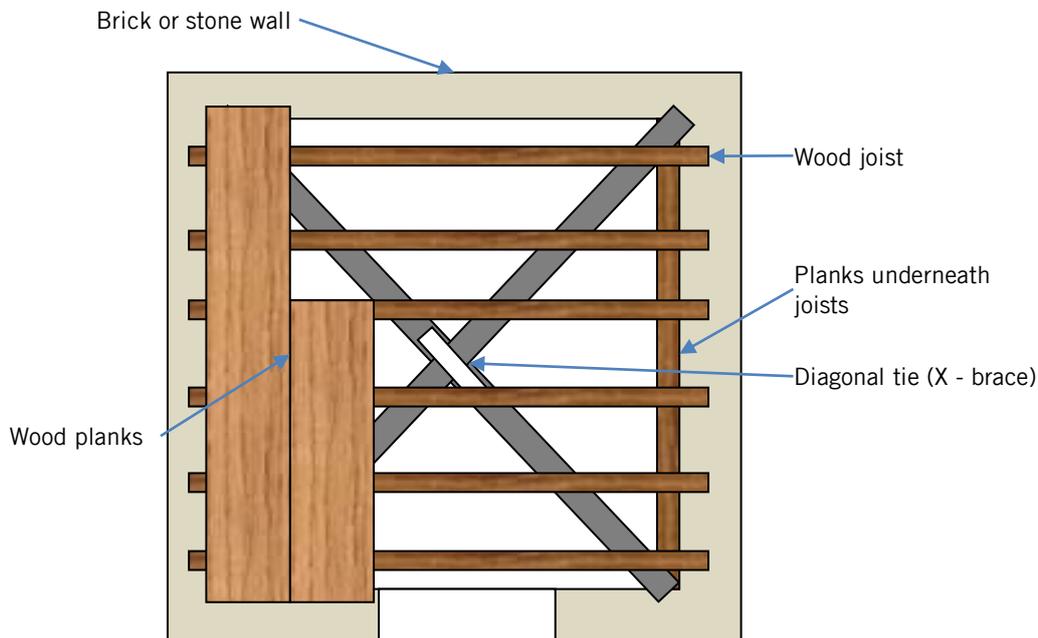
Figure 5: How to stiffen a flat roof/floor based National Disaster Management Division, Govt. of India (2006).

Having a stiff roof that is capable of diaphragm action is important, as this allows loads to be distributed more evenly to the walls to which they are connected. A roof that acts as a diaphragm is able to transfer lateral loads to walls that are able to take in-plane shear. Many flat roofs that are made with parallel timber joists and covered by either earth or planks cannot act as a rigid diaphragm. The roof (or floor) needs to be diagonally braced. Arya (2003) suggests that planks similar to that already used, or galvanised metal strips (1.5mm x 50mm) should be used to create an X-brace. The timber joists should also be nailed at both ends to joists below.

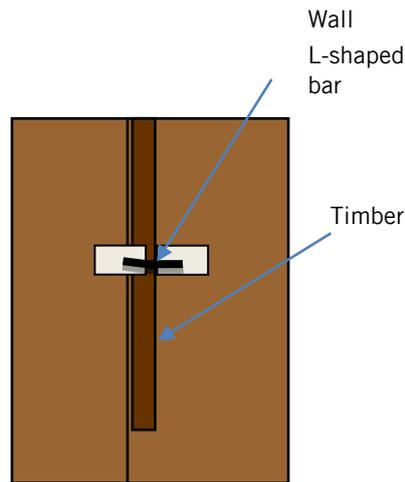
Figure 6: example improved connection between adjacent walls, based on UNDP India (2007).

Connections between adjacent masonry walls can be improved by steel reinforced connection, similar to the shear connections mentioned previously. This could consist of L shaped rods anchored and cemented into holes in the walls, to hold the timber post (see sketch).

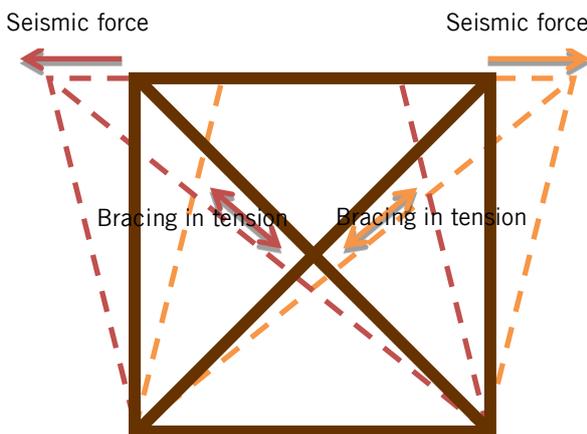
Placing diagonal members helps the wall to withstand seismic forces in plane, reducing the amount of lateral sway. Diagonal bracing ensures the load is transferred correctly to the timber members. X-bracing is generally better than diagonal bracing since it can take lateral load in both directions. Also, the wider the base of the triangle relative to the height, the stronger the configuration (Tobriner, 1999).

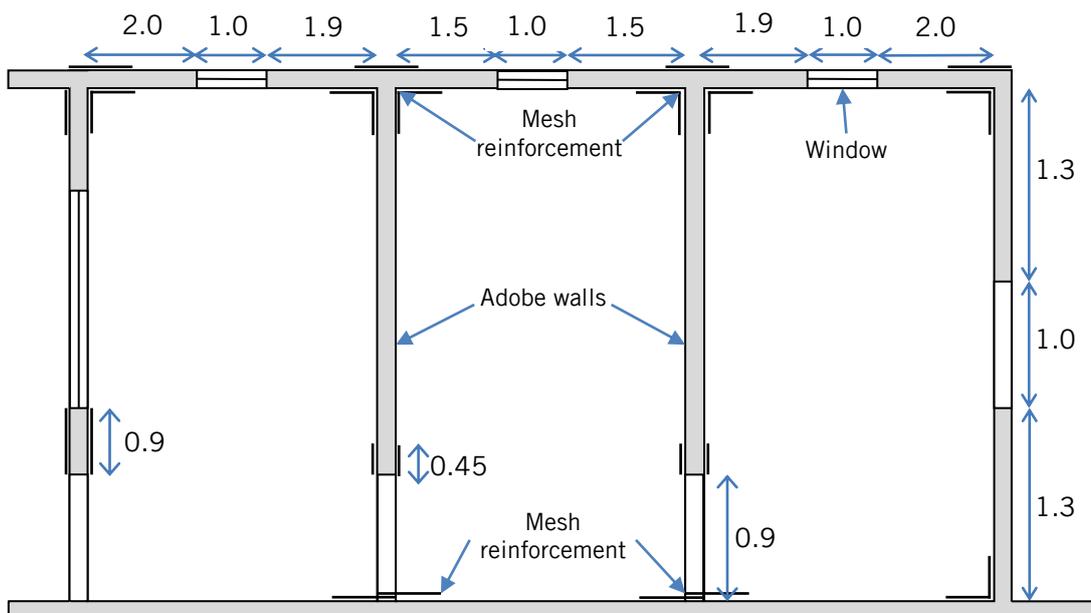
Figure 7: Illustration of wire mesh retrofit locations for a house in Guadalupe, Peru based on San Bartolome et al. (2004).

A pilot project in Peru was implemented in 2004, retrofitting 20 houses in 6 towns based on the research carried out by the Pontifical Catholic University of Peru (PUCP). The retrofit involved attaching vertical strips welded steel mesh to the corners, intersections and intermediate of long walls, with horizontal strips of mesh at the tops of walls. The mesh had typically 1mm diameter wires with 19mm spacing. It was then covered with a cement mortar. This aimed to delay collapse of an adobe masonry building by providing additional ductility.

An earthquake shook Peru of 7.9 Mw magnitude on 15th August 2007 just offshore near the town of Pisco. While 80% of adobe buildings collapsed in the most affected areas, in Guadalupe, the adobe house that had been retrofitted with steel mesh by the PUCP performed well under this earthquake, failing only where the upgrade was not completed on part of a wall (San Bartolome et. al., 2008). In contrast, the neighbouring buildings were seen to collapse. This retrofit was also particularly effective because it made locals aware of the measures that could be taken to prevent collapse in the future.

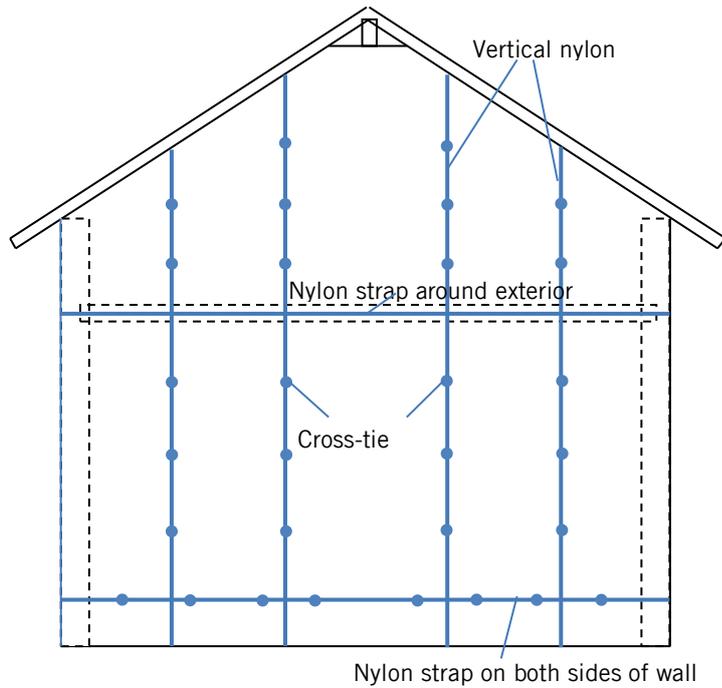
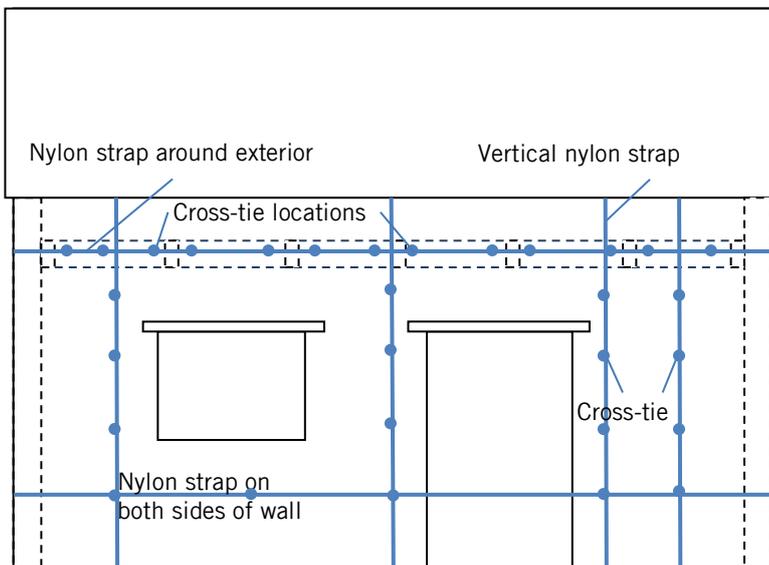
Figure 8: Sketch of nylon strap locations in Tolles et al. (2000).

The nylon straps used in the experiments on 1:5 model buildings were 0.3cm in diameter, flexible and woven. These looped vertically or horizontally around an entire wall or the whole building. The nylon cross-ties were 0.16cm in diameter and reduced crack displacement as well as providing through-wall connection.

The sketches below depict some of these installations, as carried out in the experimental study by Tolles et al (2000). The next figure depicts the retrofit on Castro-been Adobe, a two-storey adobe building part of the San Juan State Historic Monument.

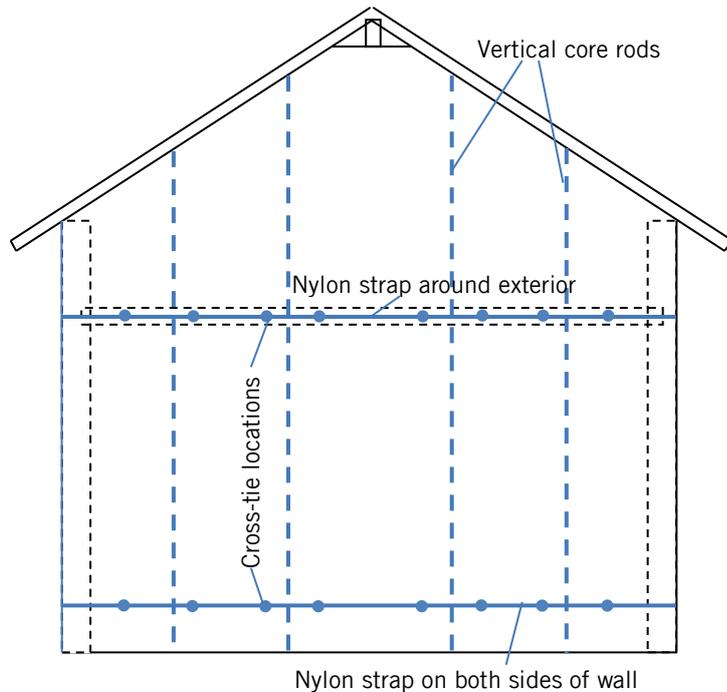
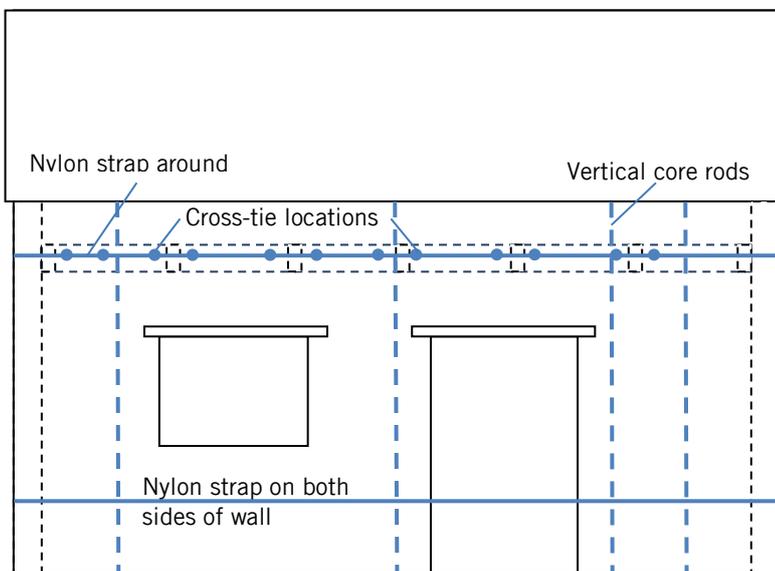
Figure 9: Sketch of vertical bar locations in experimental study by Tolles et al. (2000).

The vertical centre core elements in the model buildings were made of 0.3cm diameter steel drill rod, drilled into the adobe. During the real-life retrofitting of the historical buildings, 2cm diameter rods were used installed in 5cm diameter holes and filled with a non-shrink cementious grout.
